**American Bonanza Society  
Air Safety Foundation**

# **Landing Gear Inspection Checklist and Repair Guide**

**For Beechcraft Bonanza, Debonair,  
Baron and Travel Air**

# **Landing Gear Repair Guide**

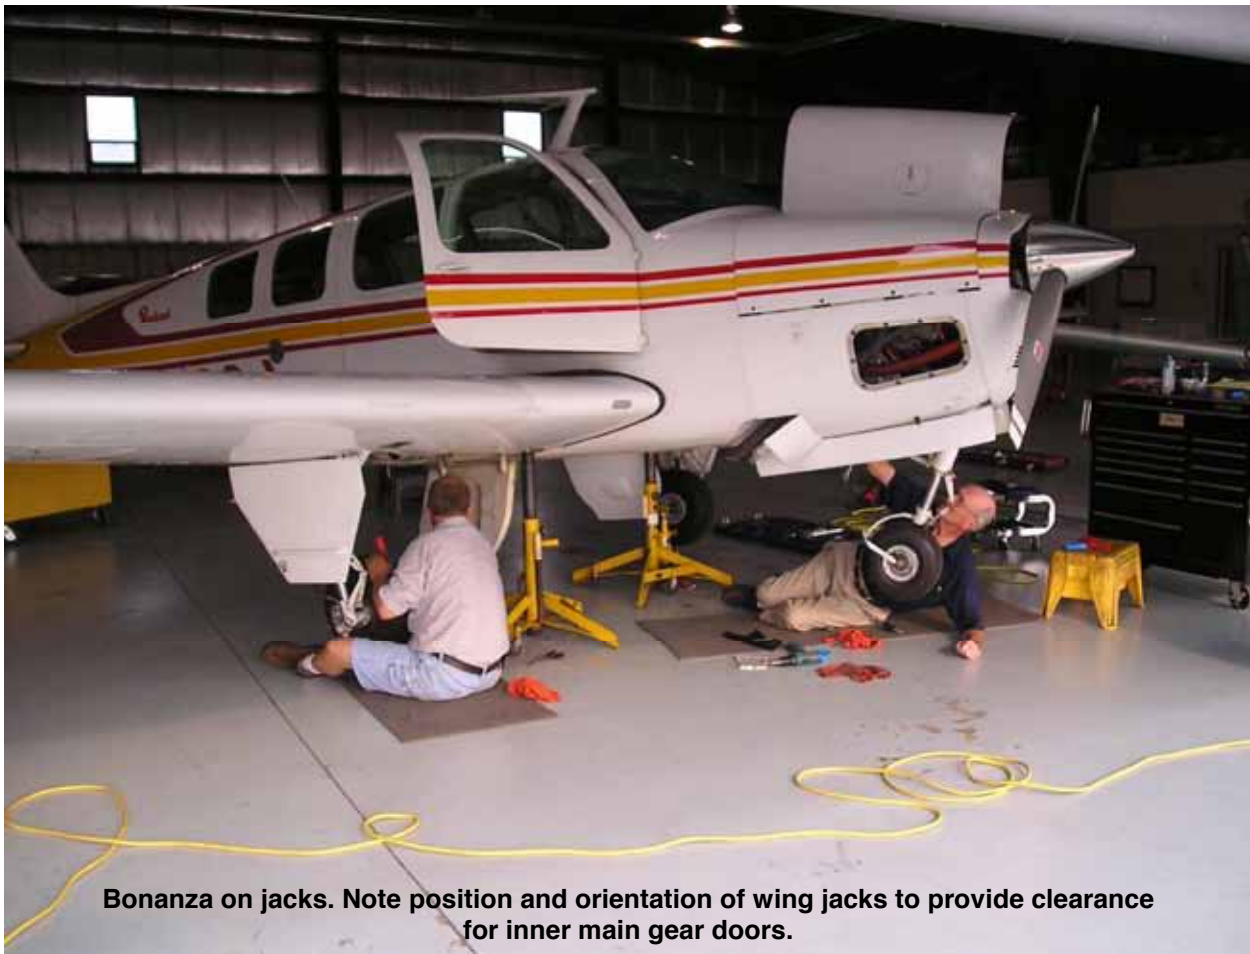
**Bonanza on jacks. Note position and orientation of wing jacks to provide clearance for inner main gear doors.**

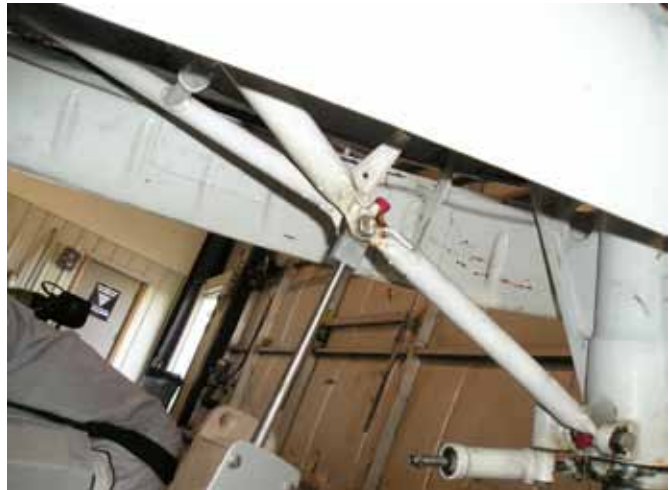
**Checking the nose gear down tension with a mechanical push-pull force gauge.**

Using a calibrated mechanical or digital push-pull force gauge, push on the knee joint of the lift leg and check the force required to deflect the joint. Record the results of all three landing gear and compare them to the tolerances listed by model in the maintenance manual. Note: keep push-pull force gauge approx. 90 degrees to lift leg when performing this check. On twin-engine aircraft equipped with the positive downlock mechanism, this system must be disconnected in order to perform a main gear down lock tension check.

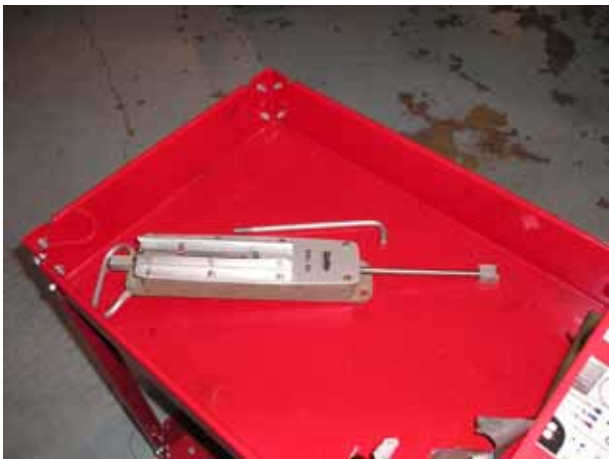
**Chatillon Model 80D mechanical push-pull force gauge. This commonly used gauge is no longer in production.**

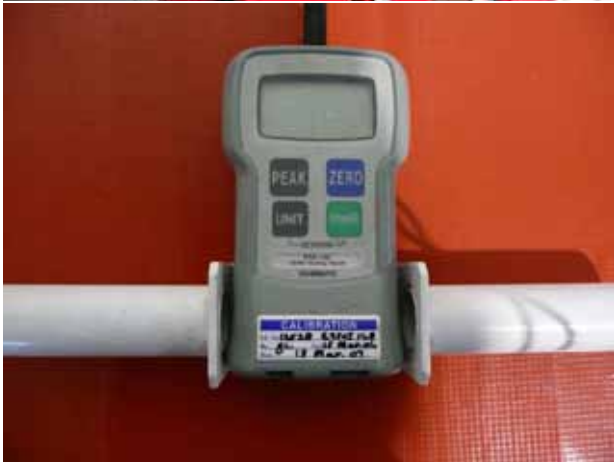
**Shimpo FGE-100 digital push-pull force gauge. Note there are several models of push-pull force gauges that can be used.**

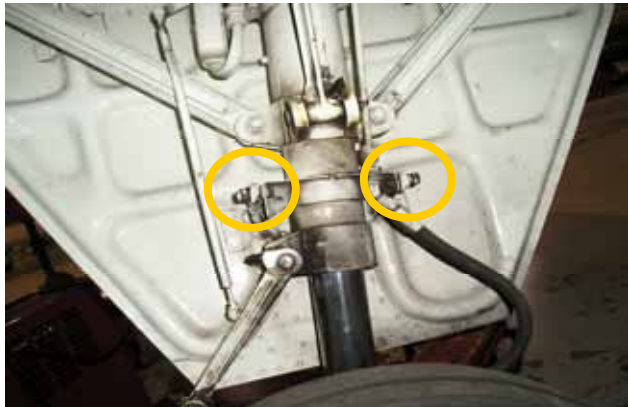
**Outer gear door disconnect points**

Leave the outboard gear door hanging loosely to provide access for the inspection.

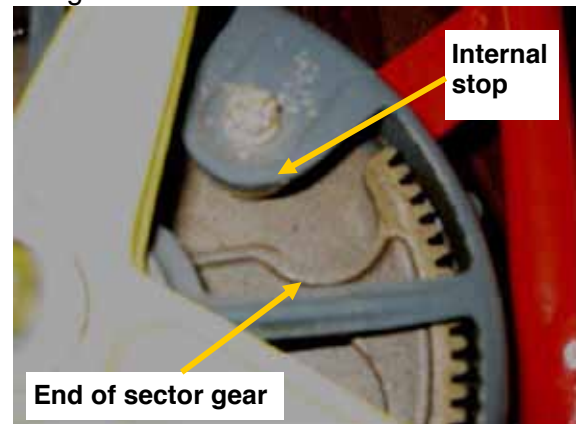
**Cutaway of a gearbox showing the sector gear approximately six turns of the hand crank from the end of cycle, but not contacting the internal stop.**

If the handcrank has less than these turns remaining with the gear down under normal circumstances, the dynamic brake may not be stopping the gear motor in time to prevent the gear box from contacting an internal stop at the end of the extension cycle. This in turn can cause the gearbox's sector gear to bend, crack or fail. If the handcrank turns too far in this condition, the gear motor and/or dynamic brake may be stopping the gear before it is fully locked down. This risks a gear collapse. This condition may also be indicated by an inner main gear door or doors that do not fully close. **STOW THE HANDCRANK.**

**Note:** If the sector gear hits the stop in either the extended or retracted position, the gearbox and motor should be removed and overhauled. The most common cause of this condition is a gear motor that is overdue for overhaul. If the motor's brushes are worn, springs are weak or the commutator is dirty or worn the motor will not stop instantly and will drive the sector gear into the stop. Do not attempt to replace motor brushes in the field. Brushes need to be run in for good brush contact with the commutator and provide proper dynamic brake operation. Send gear motors to a qualified shop for overhaul.

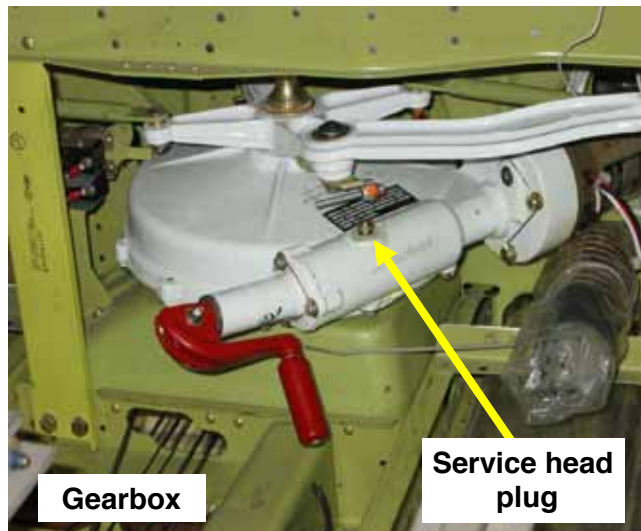
**It takes only eight ounces of fluid to fully service a completely empty gearbox.**

A common indication of an over-serviced gearbox is leaking fluid on the cabin interior below the landing gear emergency handcrank.

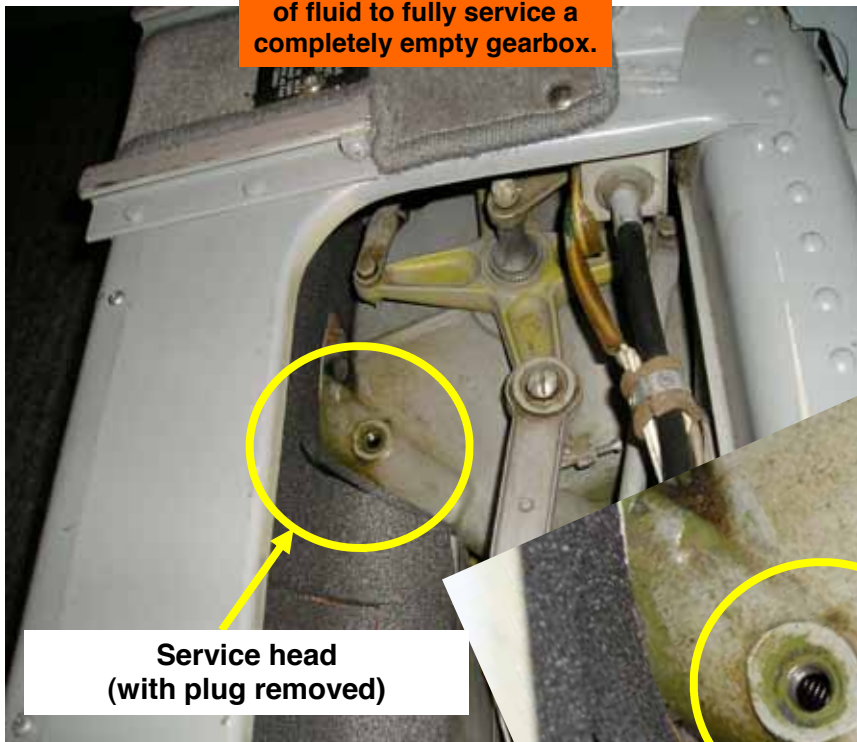
Looking down at the gearbox, beneath the copilot seat

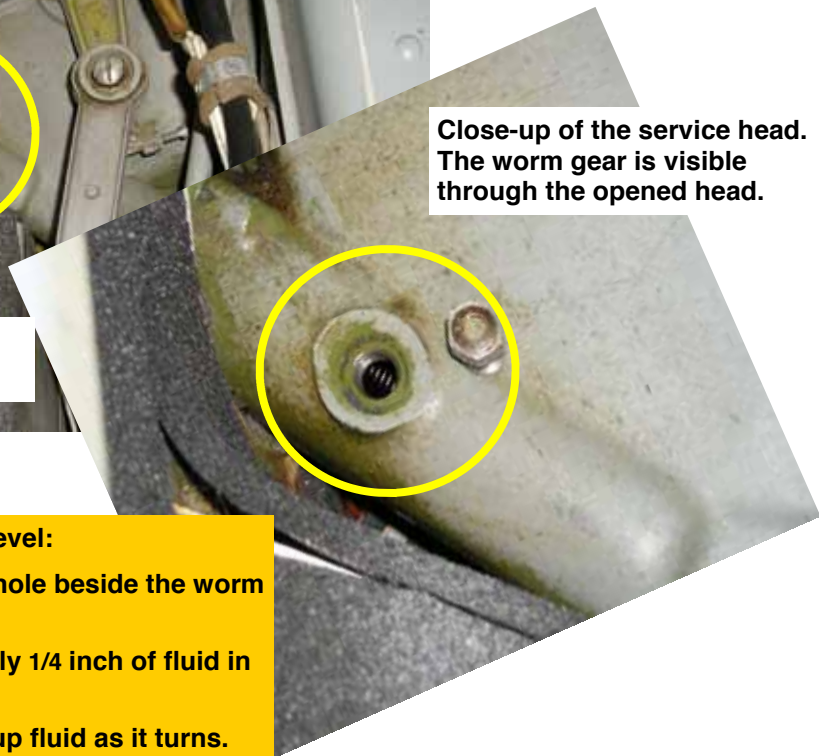
Close-up of the service head. The worm gear is visible through the opened head.

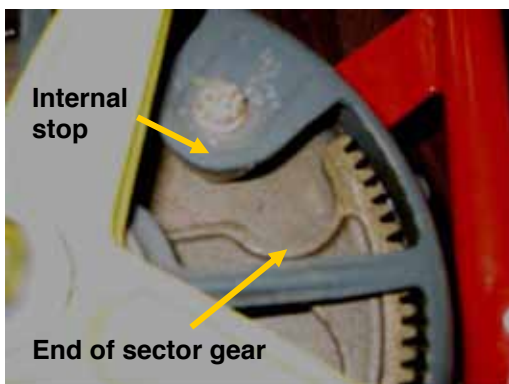
Sector gear near but not contacting the internal stop.

Gearboxes originally painted green should have  $1/8$  to  $1/4$  turn tolerance and gearboxes originally painted white should have  $5/8$  to  $3/4$  turn remaining at the end of electric travel. Many airplanes have been retrofitted with earlier or later gearboxes, and many originally green gearboxes have been erroneously painted white when overhauled.

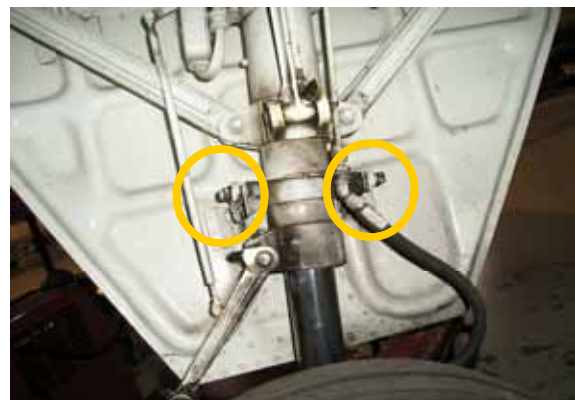
**Outer gear door connection points**

To reconnect the outer door the hardware sequence is: Both fore and aft bolt heads face the strut. The forward connection is bolt through the bracket, two washers, the link rod end, one washer and the nut. The aft connection is the bolt through the bracket, one washer, the link rod end, one washer and the nut.

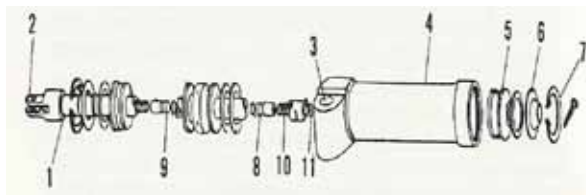
**Shimmy damper**

The shimmy damper should have no play, and show no sign of leaks.

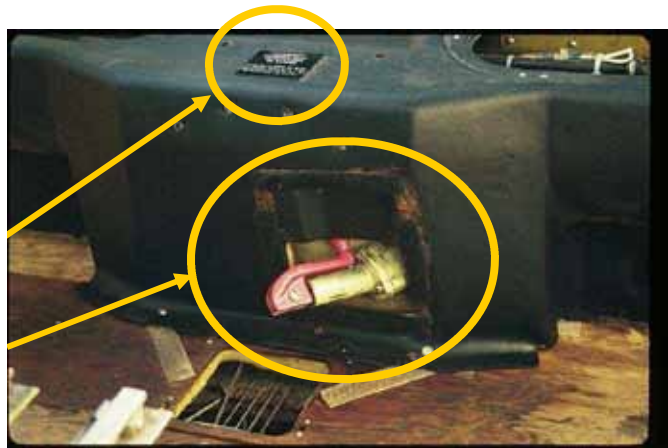
Improperly installed spar cover and obstructed handcrank

It is quite common that mechanics install the forward spar cover (in later models) so that the hard plastic covers the stowed landing gear emergency handcrank. The plastic is very hard and tolerances in this condition very tight. It is not possible to unstow the handcrank in this condition, so it would prevent a manual landing gear extension in the event the gear could not be extended electrically.

**38. After the cabin inspection is complete, ensure the manual extension handle is stowed and it is not blocked by the spar cover. Install the protective boot or cover.**

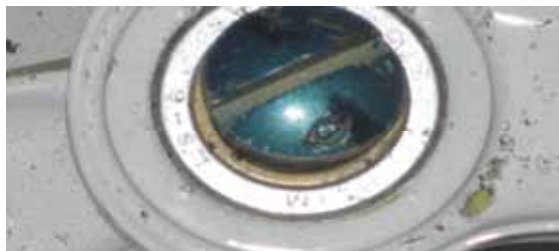
Loose bolt

Note: The main gear may be sagging off the up stop in the up position if the attach hardware is loose.

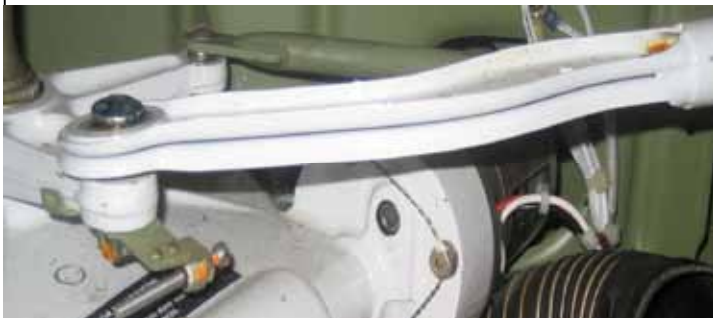
Flat area of the retract rod

1. Inspect the flat area of the retract rod for flexing up or down. Preload the rod by lifting the main wheel and collapsing the plunger on the outboard end of the rod, or watch the operation of the rod during an extension cycle for flexing. A frozen plunger may cause this problem.

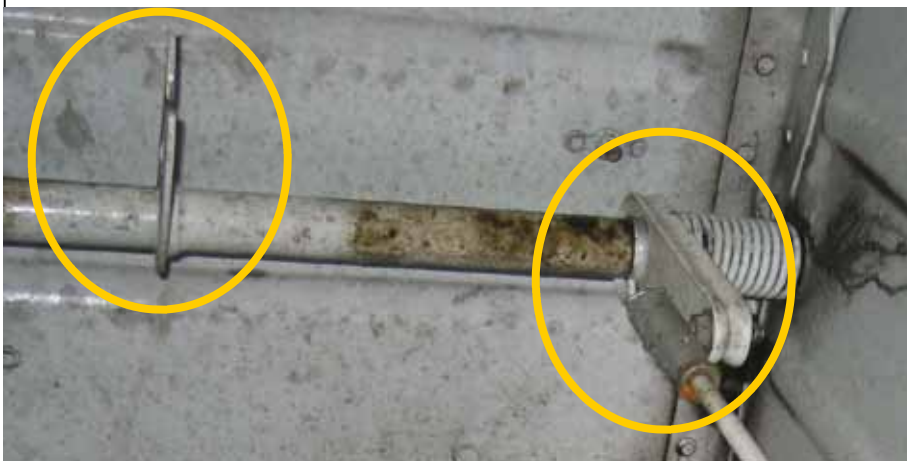
Nose gear door actuator arm (right) and door actuator pin guide (left)

1. Check the nose gear door actuator guide, especially the upper side of the guide, for cracks or to see if it is broken off. Lubricate the guide with a light grease to reduce wear on the guide and on actuating pin.
2. Check for damage on the door actuator pin.
3. On single-engine airplanes with cowl flaps, check for wear on the cowl flap actuator cross-shaft bearing plates at the ends of the shaft, attached to the nose gear tunnel. The nose gear door actuator rotates on this shaft. Excessive wear on the bearing plates can create alignment problems with the guide and pin.
  - (1) Replace worn bearing plates.
  - (2) Grooves worn in the shaft may be welded and then lathed to shaft diameter.
4. Cracks aft of the forward door hinge on the inside or the door may be repaired with a doubler, structural adhesive and blind rivets.

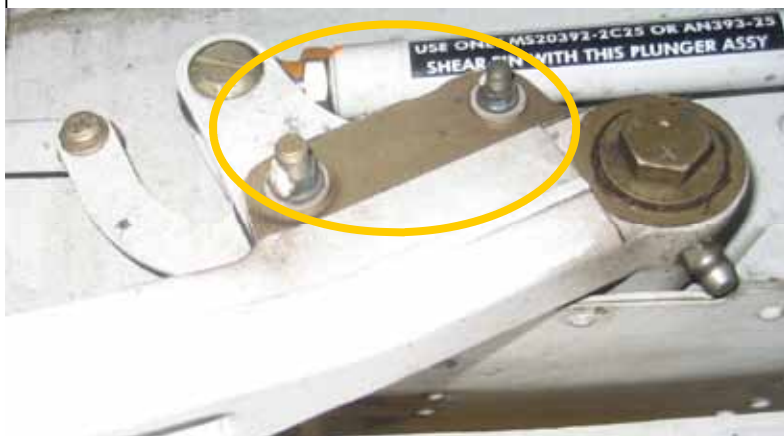
Retract rod mounting bolts

Beechcraft recommends a 2,000 hour inspection of the two (2) bolts and two (2) drag brace brackets. (NOTE – the Illustrated Parts Catalog refers to the brackets as inboard and outboard arms.)

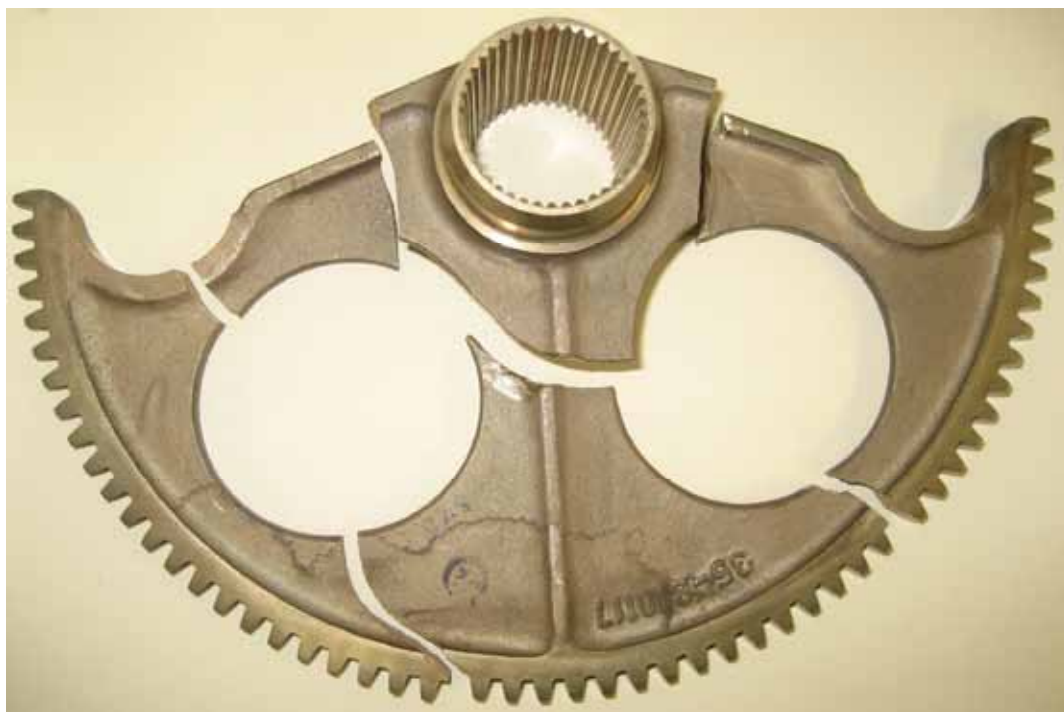
The sector gear from a 28-volt airplane that hit the internal stop on both sides repeatedly for a long period of time. The sector gear became work hardened and brittle, and eventually shattered.

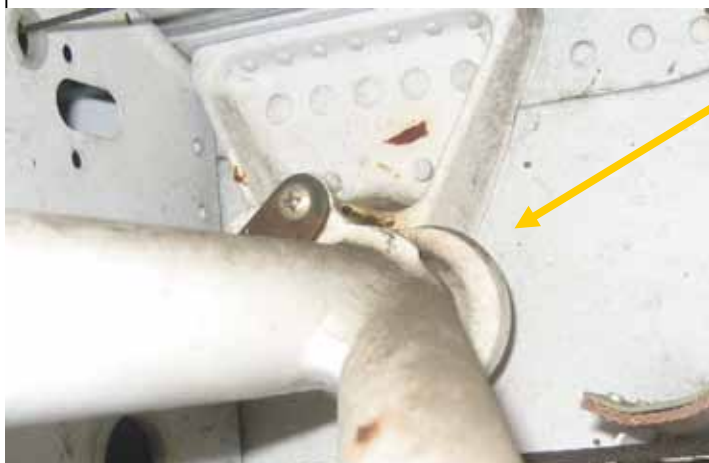
Mounting boss and lift leg bushing

- (1) Check the mounting pin for wear.
- (2) If the pin is good, replace the bushing.
- (3) If the pin is worn, replace the pin and the bushing.

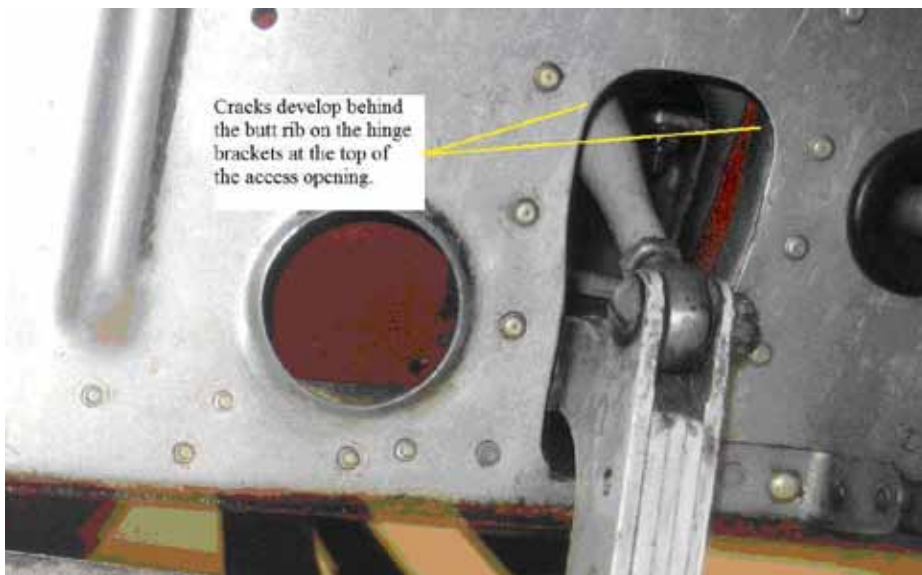
Forward hinge brackets will crack occasionally on the forward and aft sides of the access hole. You may have to remove the lower wing root fairing for access.

- (1) Manufacture a small doubler with a 90-degree angle to reinforce the bracket.
- (2) Install doubler with structural adhesive and rivet to the butt rib with Cherrymax-type blind rivets.

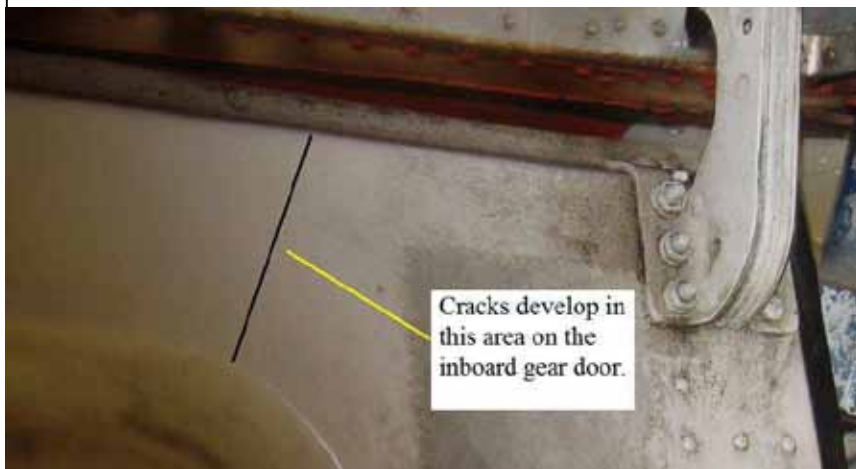
### Discrepancy: Main gear inboard door cracks

A locally manufactured doubler (this may take some craftsmanship) installed with structural adhesive and blind rivets makes a good repair. Use scrim cloth with the adhesive.

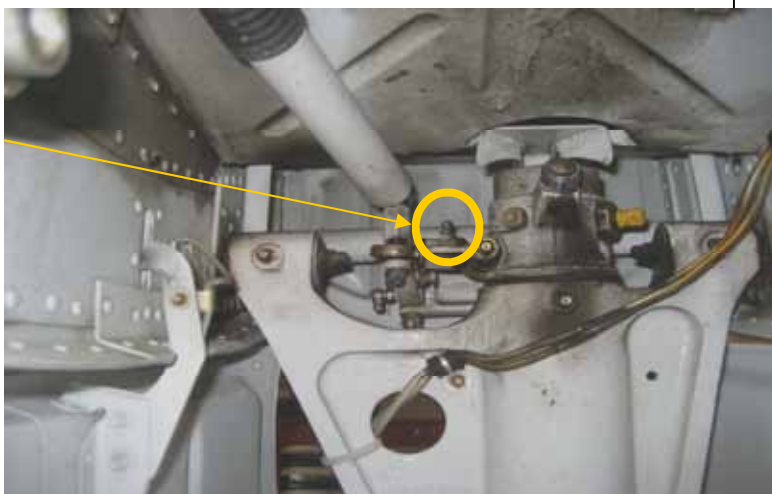
Top of the nose gear strut. Note the grease fitting is installed incorrectly, a common mistake. The fitting should be installed pointing *down* to avoid interference during gear transit and to facilitate greasing.

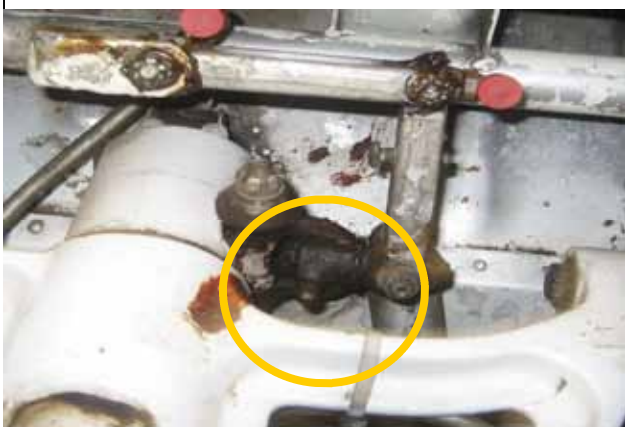
(above) Properly installed grease zerk, pointed down.

- (1) Remove the steering yoke from the strut cap.
- (2) Support the yoke in a bench vice.
- (3) Break off the pressed-in grease fitting (P/N 1736).
- (4) Use a pin punch to drive the remaining section of the zerk through the bushing.
- (5) Use a new bushing to push out the old bushing, then install the new bushing.
- (6) Drill a grease port in the bushing and press in new grease fitting. Install the yoke with grease fitting down to prevent interference when the gear is in transit.

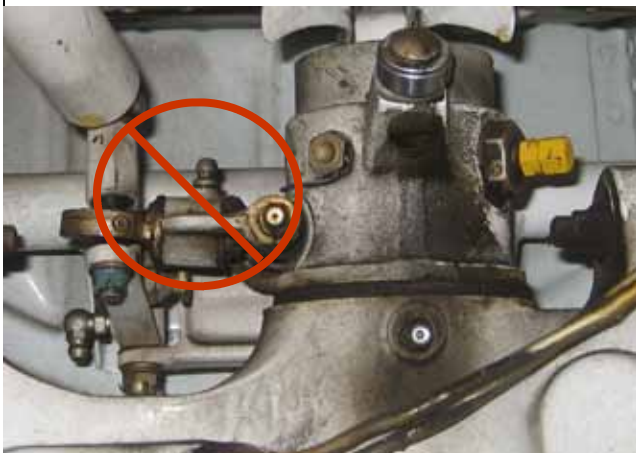
(below): Improperly installed grease zerk, pointed up.

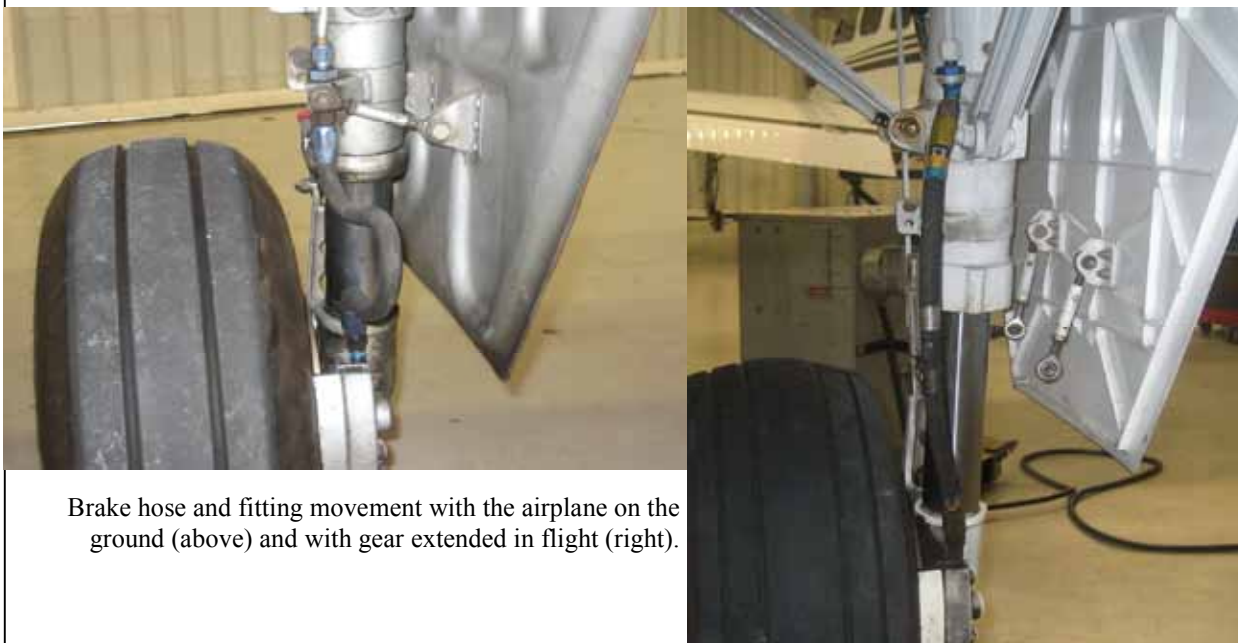
Brake hose and fitting movement with the airplane on the ground (above) and with gear extended in flight (right).

**Discrepancy: Brake hoses require replacement and/or installation**

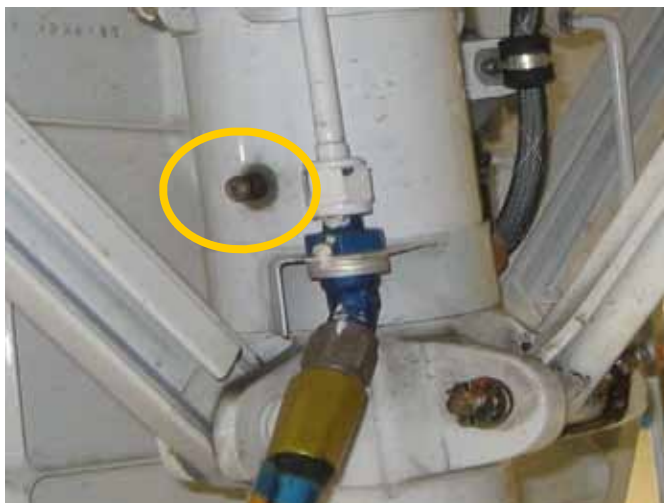
Gear strut Huck bolt

1. If a strut is bouncy it is low on oil and the strut is riding on a column of air. Servicing the strut with hydraulic fluid may require resealing.
2. A strut that has not been serviced with fluid in a long time has a good possibility of leaking during the process. When the air load is removed from the O-ring and the strut is moved full travel to service it with fluid, foreign material may lodge in the O-ring area. When a nitrogen charge is applied the strut may develop a leak at the center seal.
3. A strut may show signs of leakage in the area of the Huck bolt on the side of the strut. Fluid leakage in this area indicates that the O-ring on the outer diameter of the center bearing is leaking. Removal and reinstallation of this bearing requires special tooling. This usually means sending strut to a repair station to be rebuilt.
